Emergency Response

A Case Study of Bellevue Way Water Main Break

Utilities

March 07, 2024

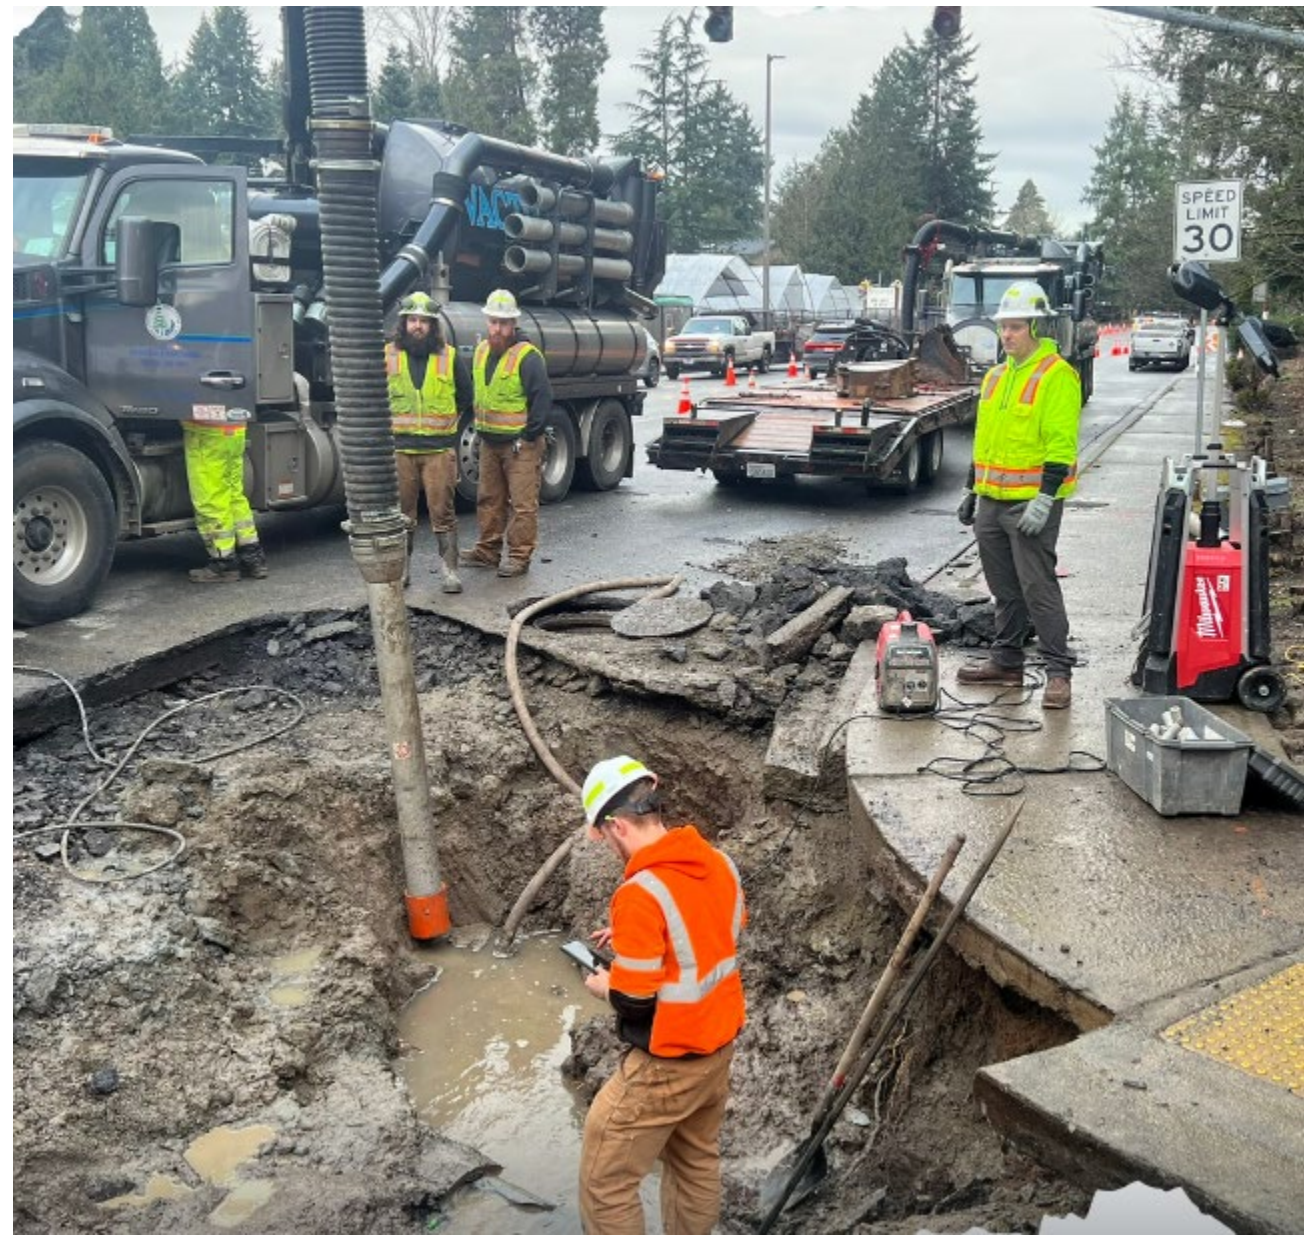
Water Main Break

Friday, February 2nd, 2024

- Reported at 1:30 am
- 1000+ GPM flowing into intersection of Bellevue Way and SE 10th Street
- 12" AC Main serving West Bellevue 400 zone
- Surrounded by nearby utility infrastructure
 - 8" Water Main underneath
 - Adjacent stormwater catch basin

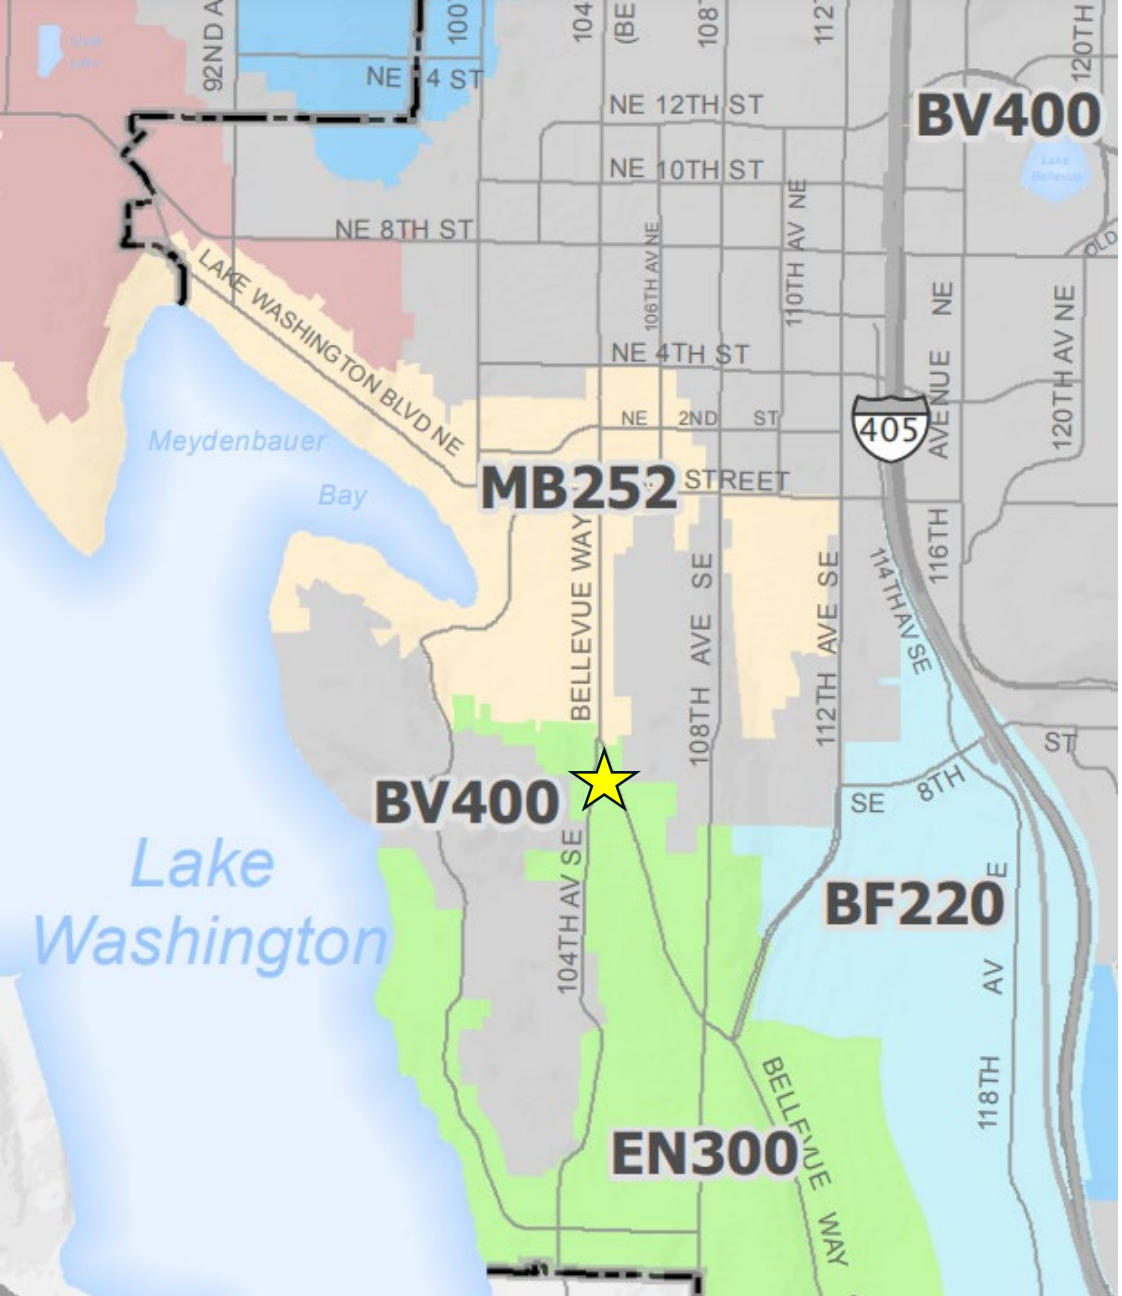
Bellevue 400 Zone

- BV400 Zone—large pressure zone feeding Downtown
- West BV400 zone served primarily by 12" AC main under SE 10th St
- Operations Standby saw rapid drop in pressure on SCADA at Meydenbauer Pump Station—indication of nearby WMB
- Operations Standby notified Water Maintenance Standby and used pump station to maintain system pressure during repairs

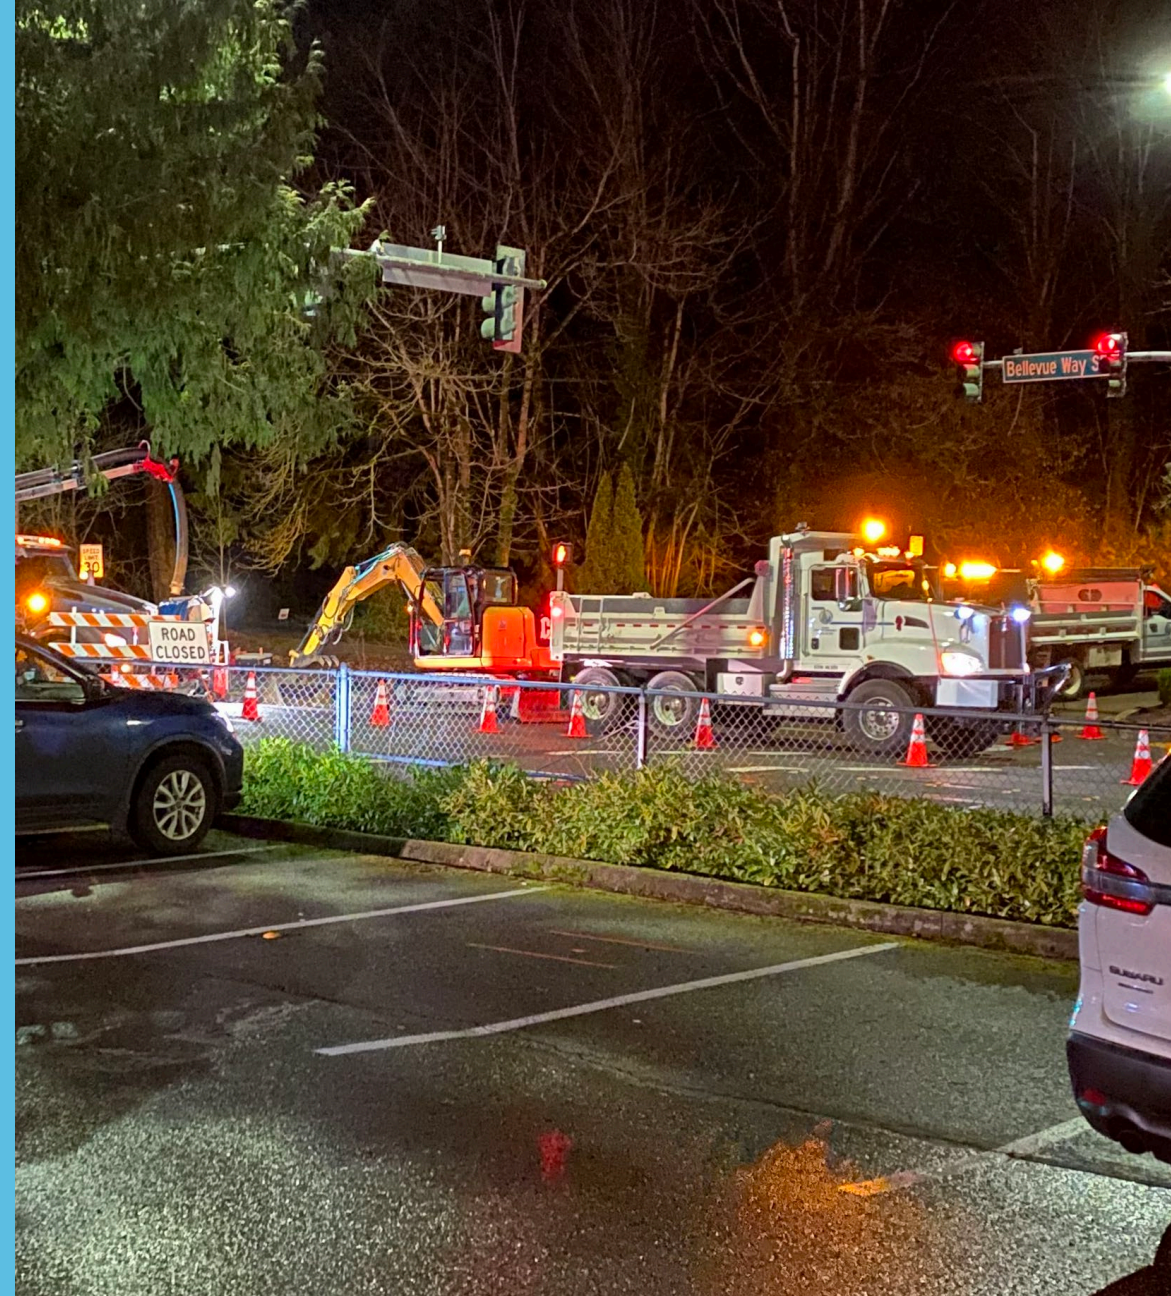
Traffic Control & Site Excavation

- Streets Maintenance established traffic control & closed northbound lanes of Bellevue Way
- Wastewater Maintenance personnel operated heavy equipment
- Stormwater Maintenance operated Vactor and dump trucks to remove excavated materials

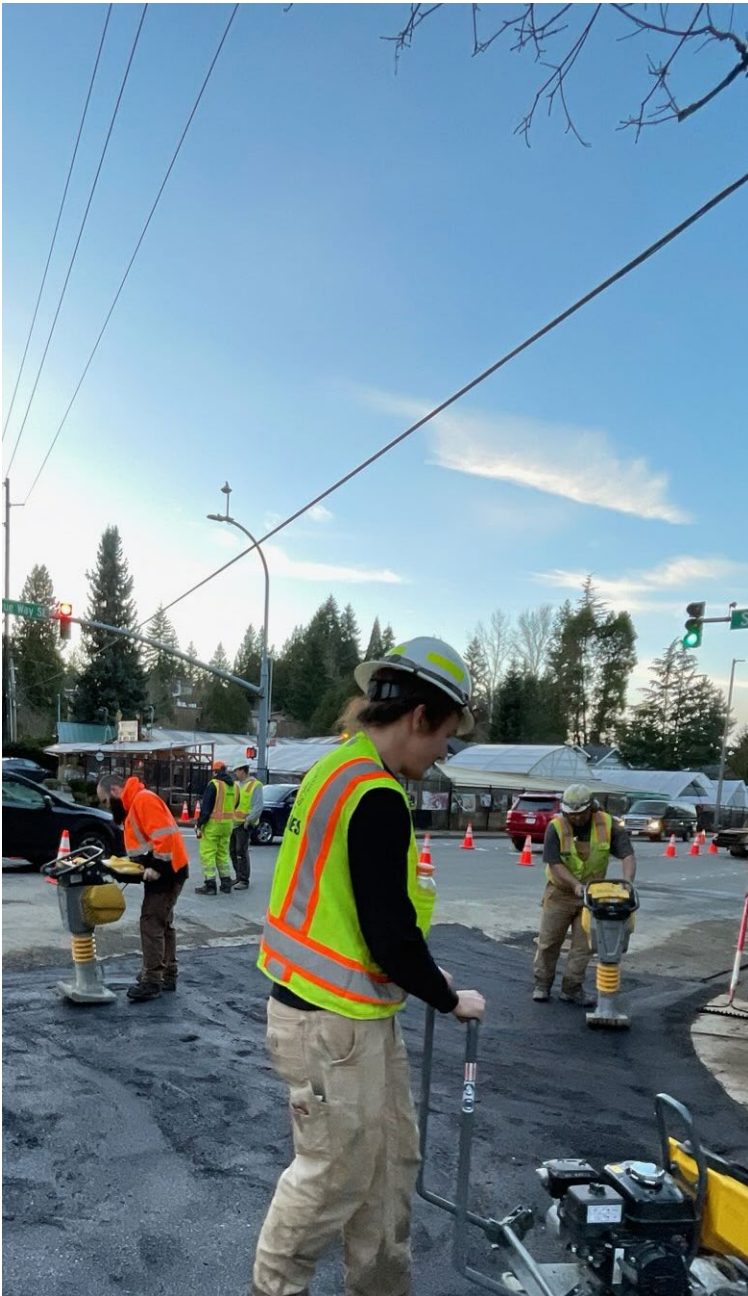
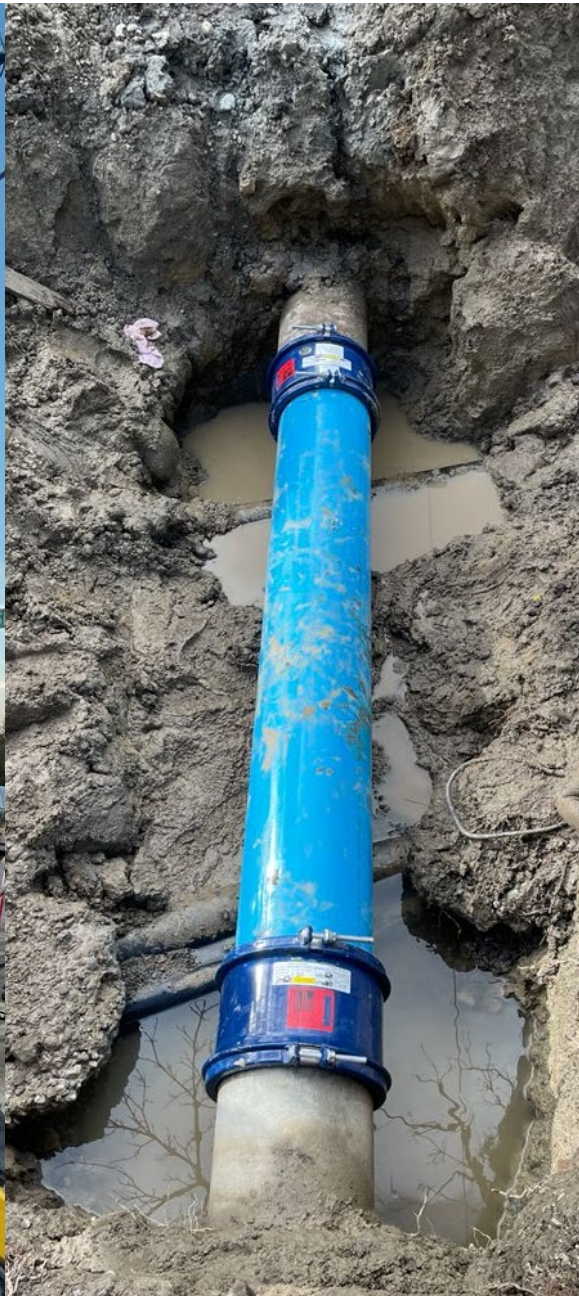
Water Main Repair

- Operated nearby water valves to reduce flow
- Cut away effected portions of water main
- Installed temporary section of 12" composite pipe
- Restored water system pressure & flow

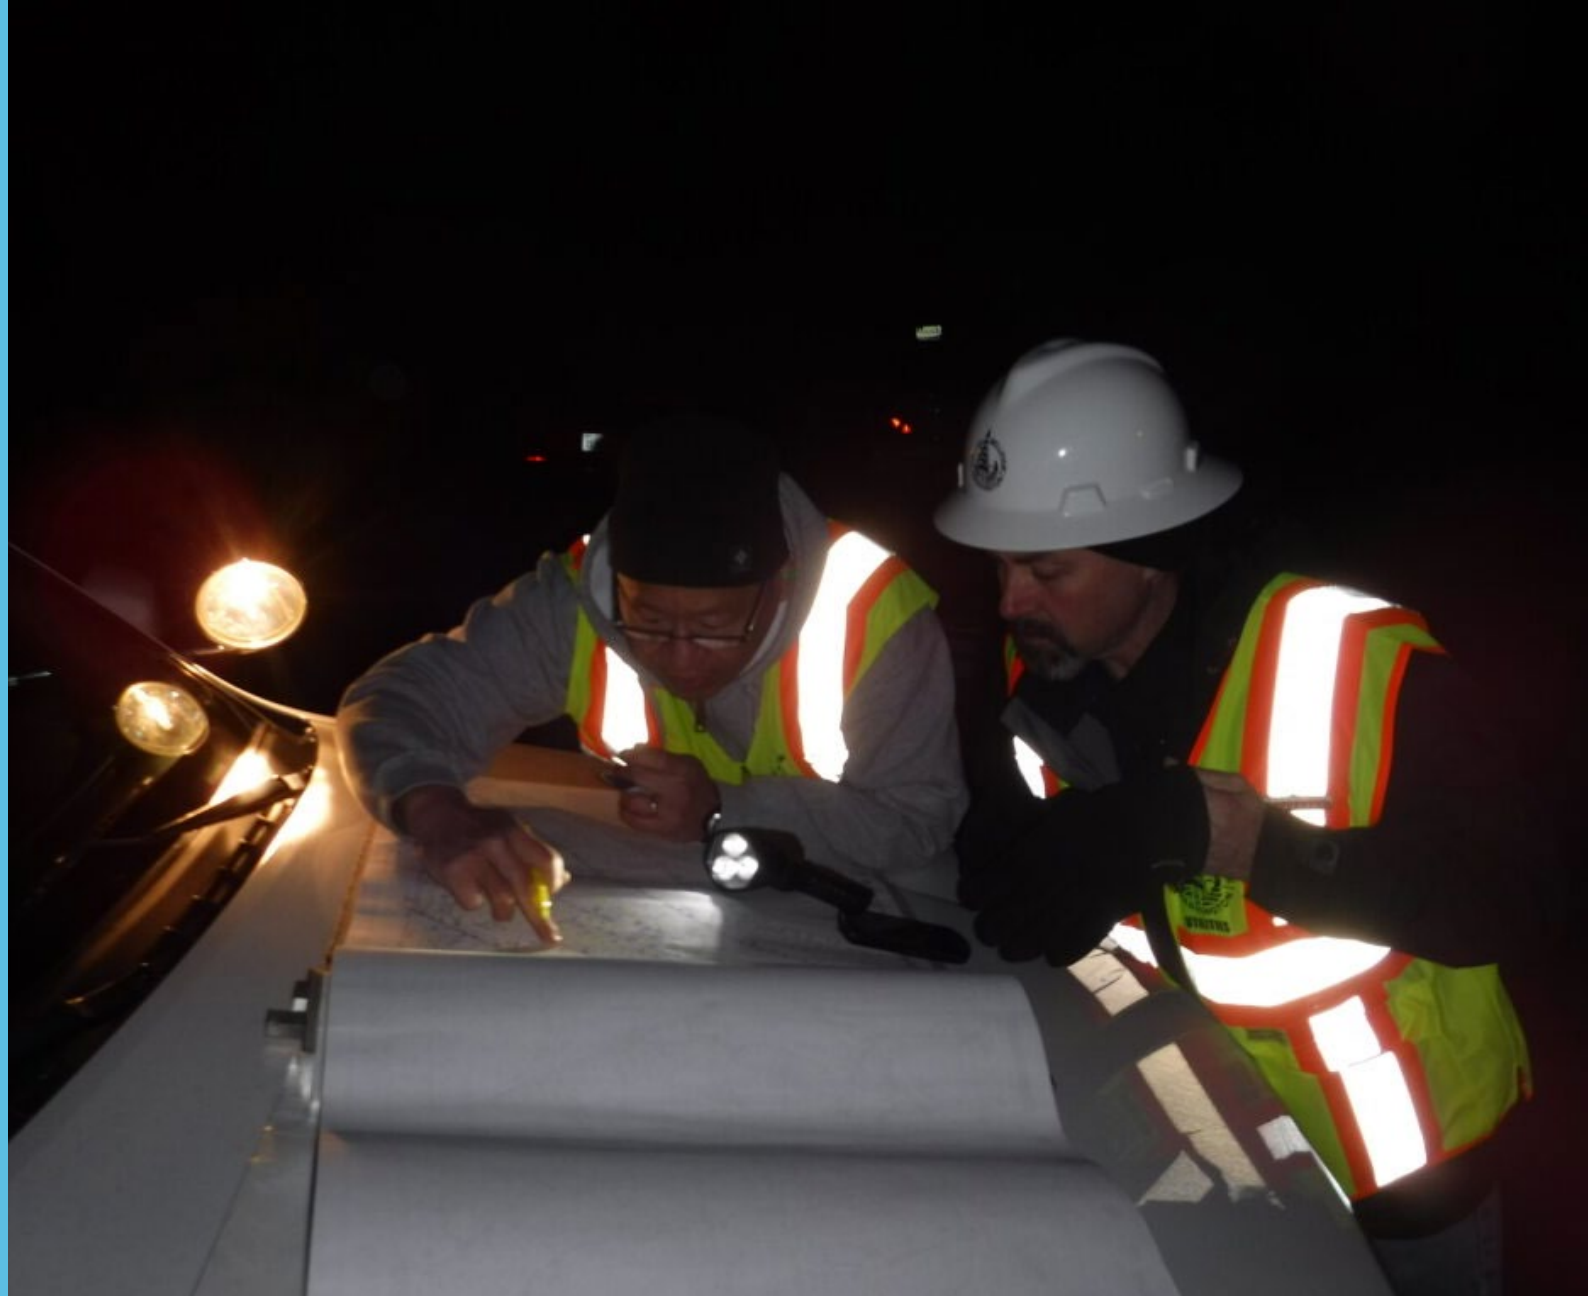
Water Quality

- Identified area of localized pressure loss.
- Coordinated with WA Dept. of Health to determine Boil Water Notice area.

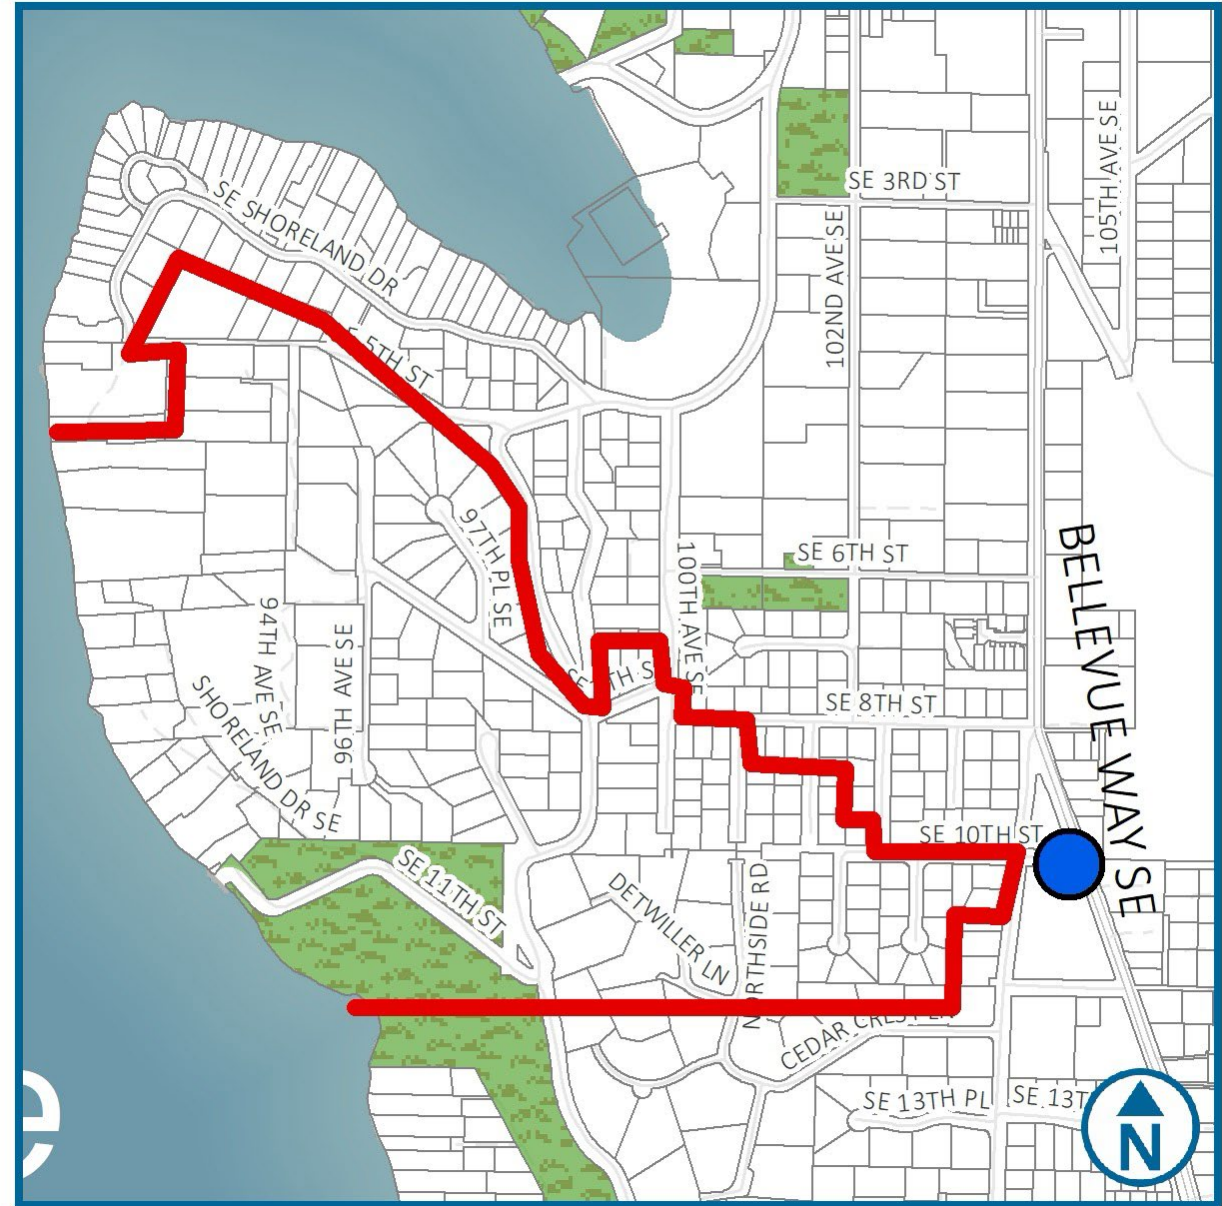
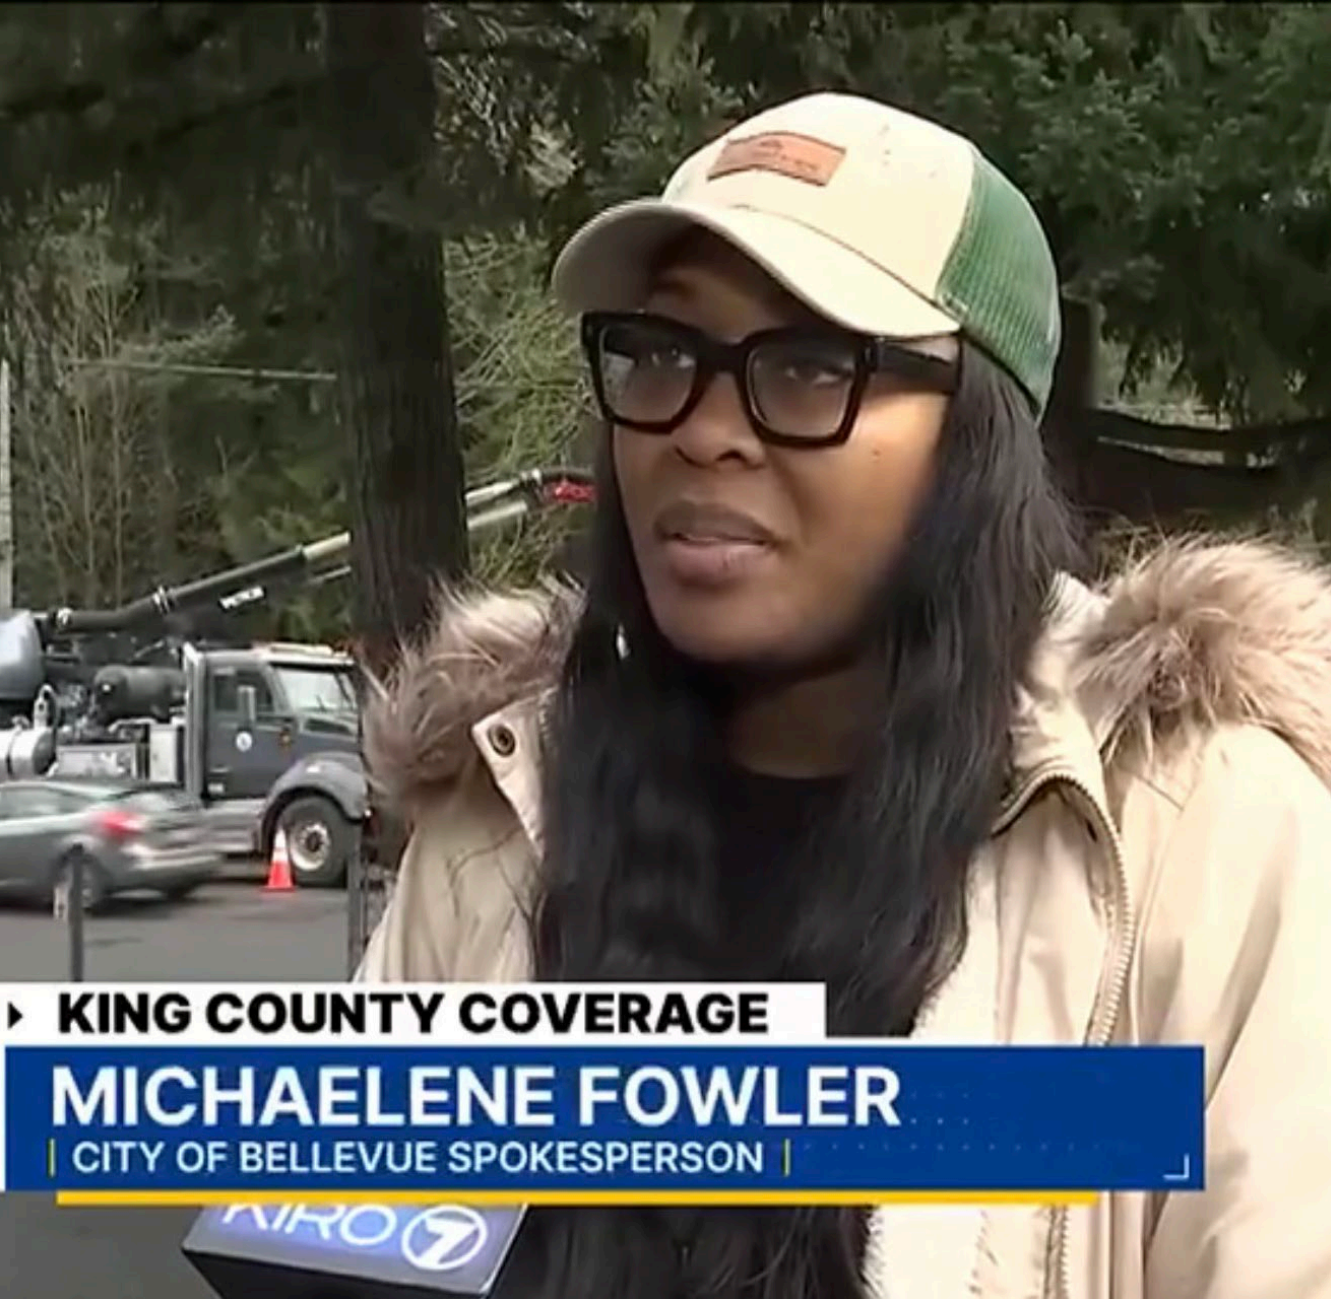
Boil Water Notice

- Type 4 Water Main Break – Loss of system pressure & potential system backflow
- Sent 5 water samples immediately for testing at SPU lab on Friday
- Received results 48 hours later— all absent of bacteriological matter
- Lifted boil water notice on Sunday
