# Seattle Public Utilities Seismic Study Summary

City of Bellevue  
Environmental Services Commission  
February 7, 2019

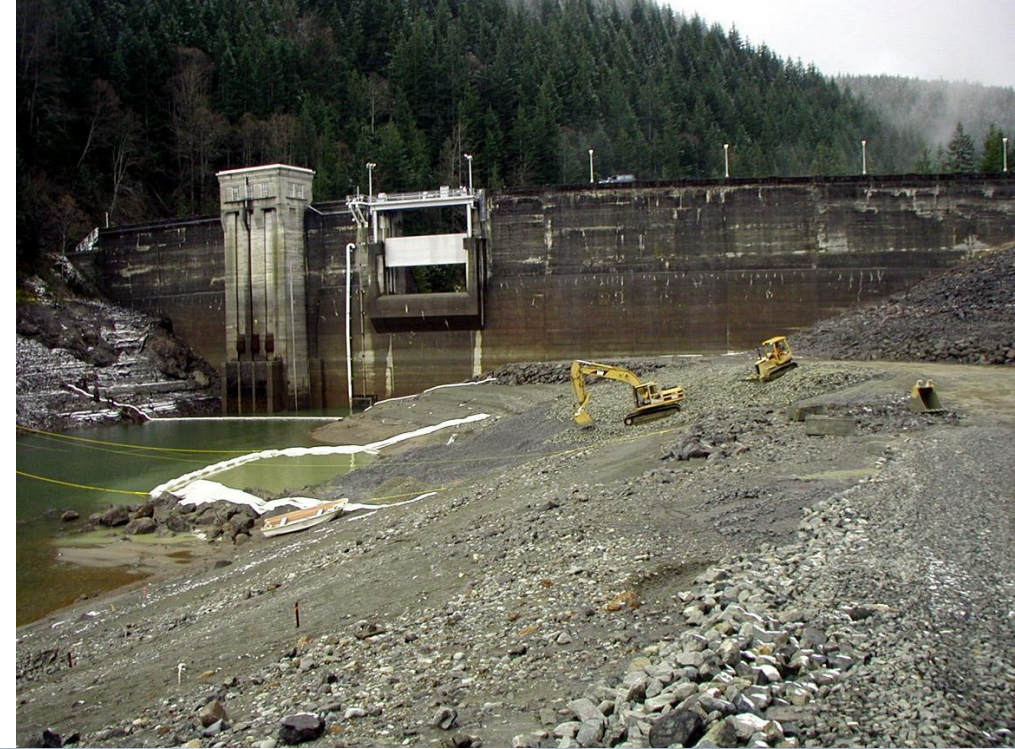
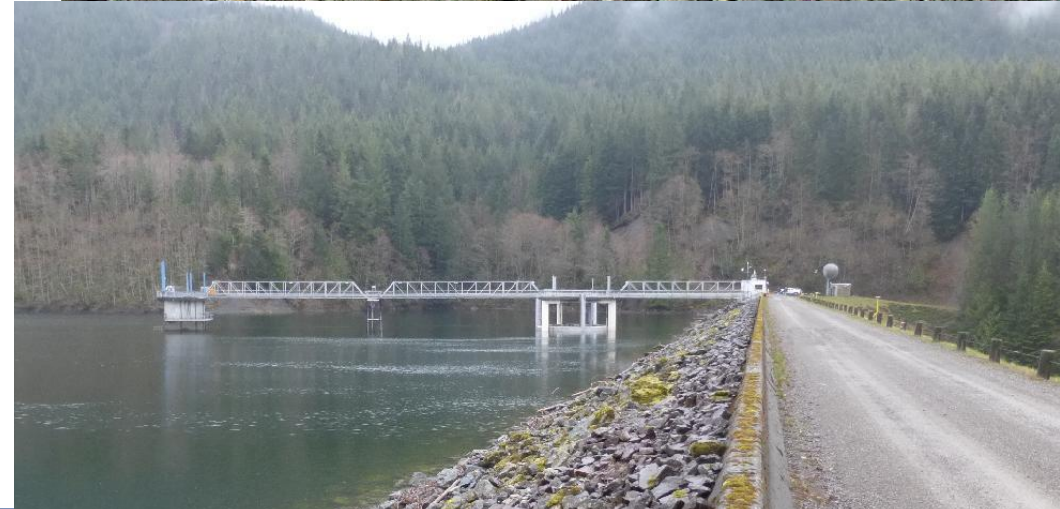
# Watersheds

- Dams – Meet FERC requirements
- Landslides
  - Minor impacts in M7.0 SFZ and M9.0 CSZ events
  - Moderate or more severe impacts possible for building code ground motions
- Other Facilities
  - Tolt intake bridge connections
  - Tolt screenhouse
  - Landsburg Tunnel Gatehouse

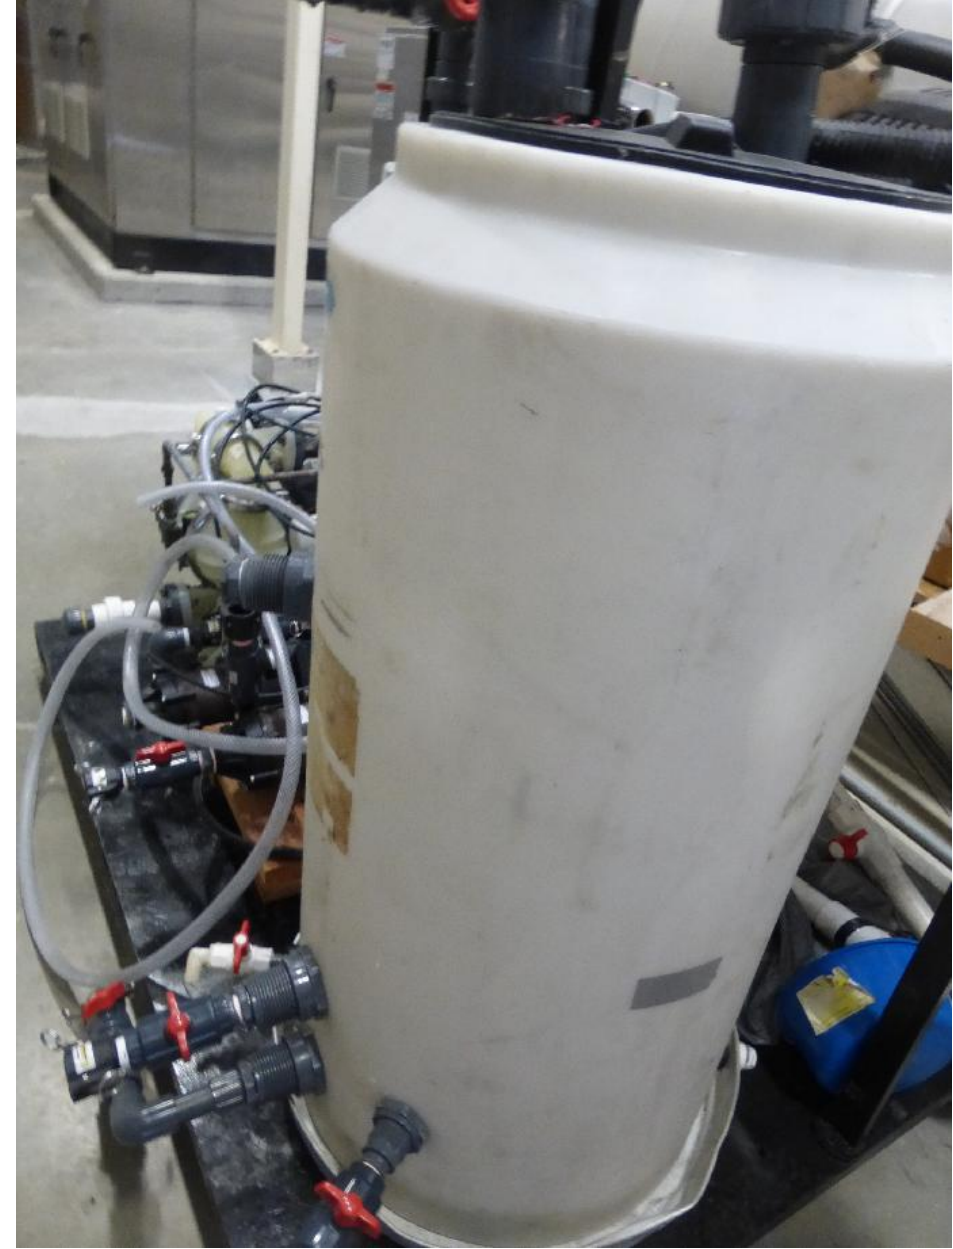
# Treatment Plants

- Structural Performance – generally good
- Some Nonstructural Concerns
- Sloshing in Basins
- Emergency Power
- Clearwells – some damage (particularly for building code ground motions) but expected to remain functional

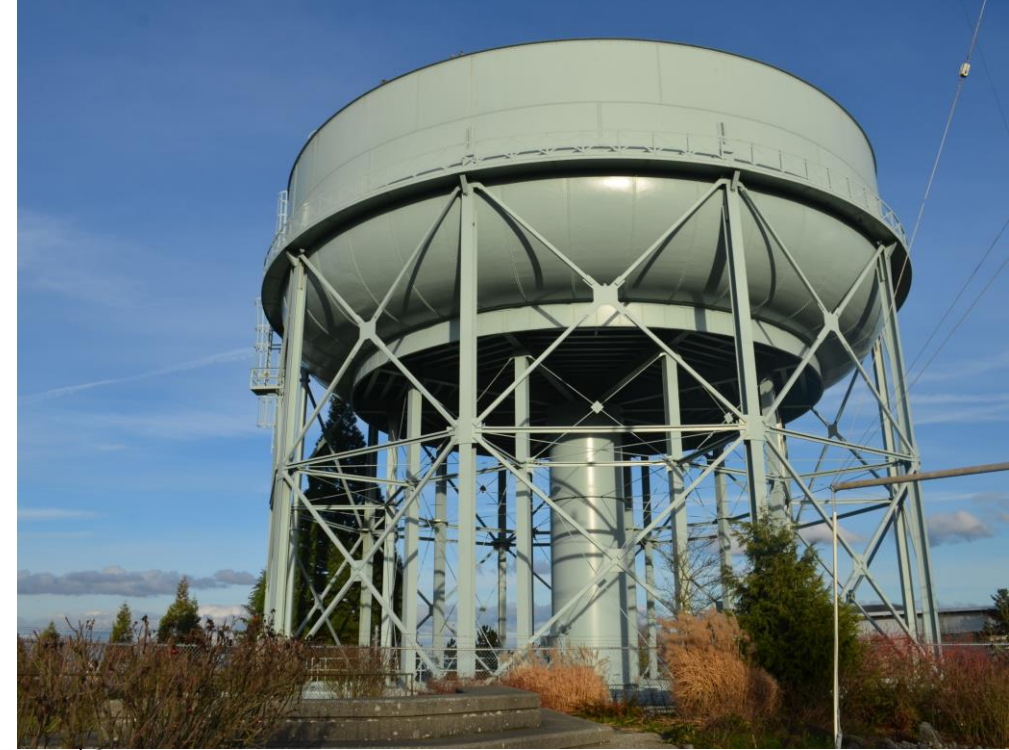
# Regional Reservoirs and Tanks

- Reservoirs
  - Riverton Reservoirs Is Most Vulnerable
  - Eastside Reservoir Also A Concern
  - Damage Possible to Other Reservoirs But Most or All Others Are Expected to Remain Functional
- Elevated Tanks and Standpipes: All Are Vulnerable to Code Level Ground Motions

Myrtle #2

Eastside Reservoir After  
Nisqually Earthquake:

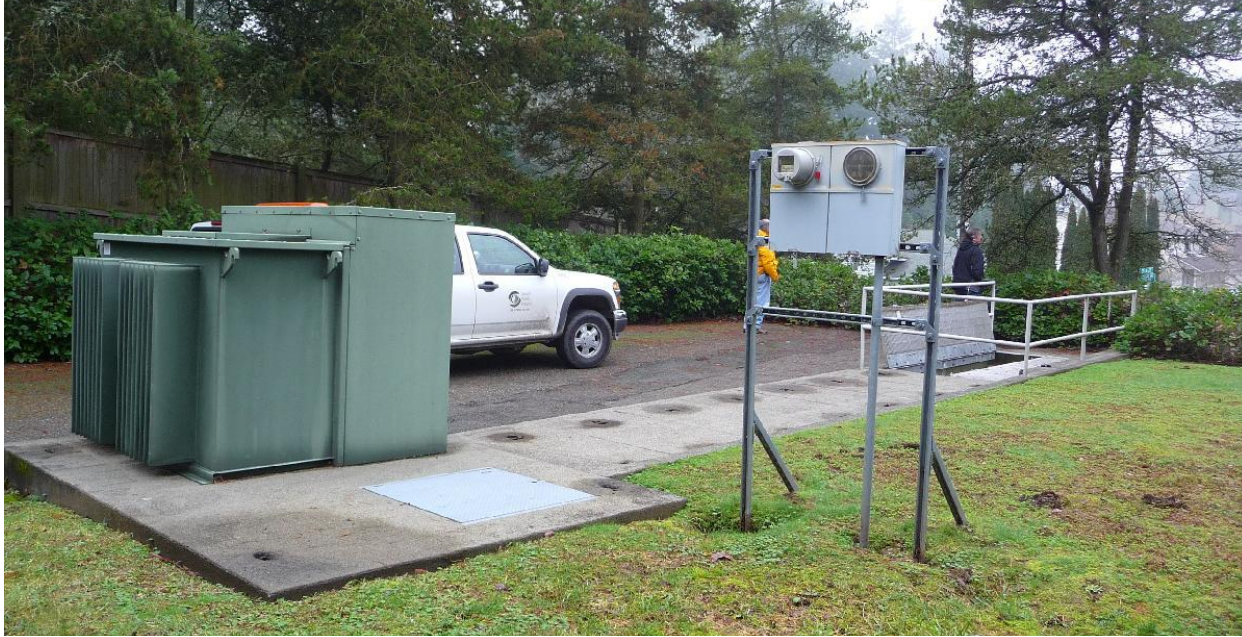
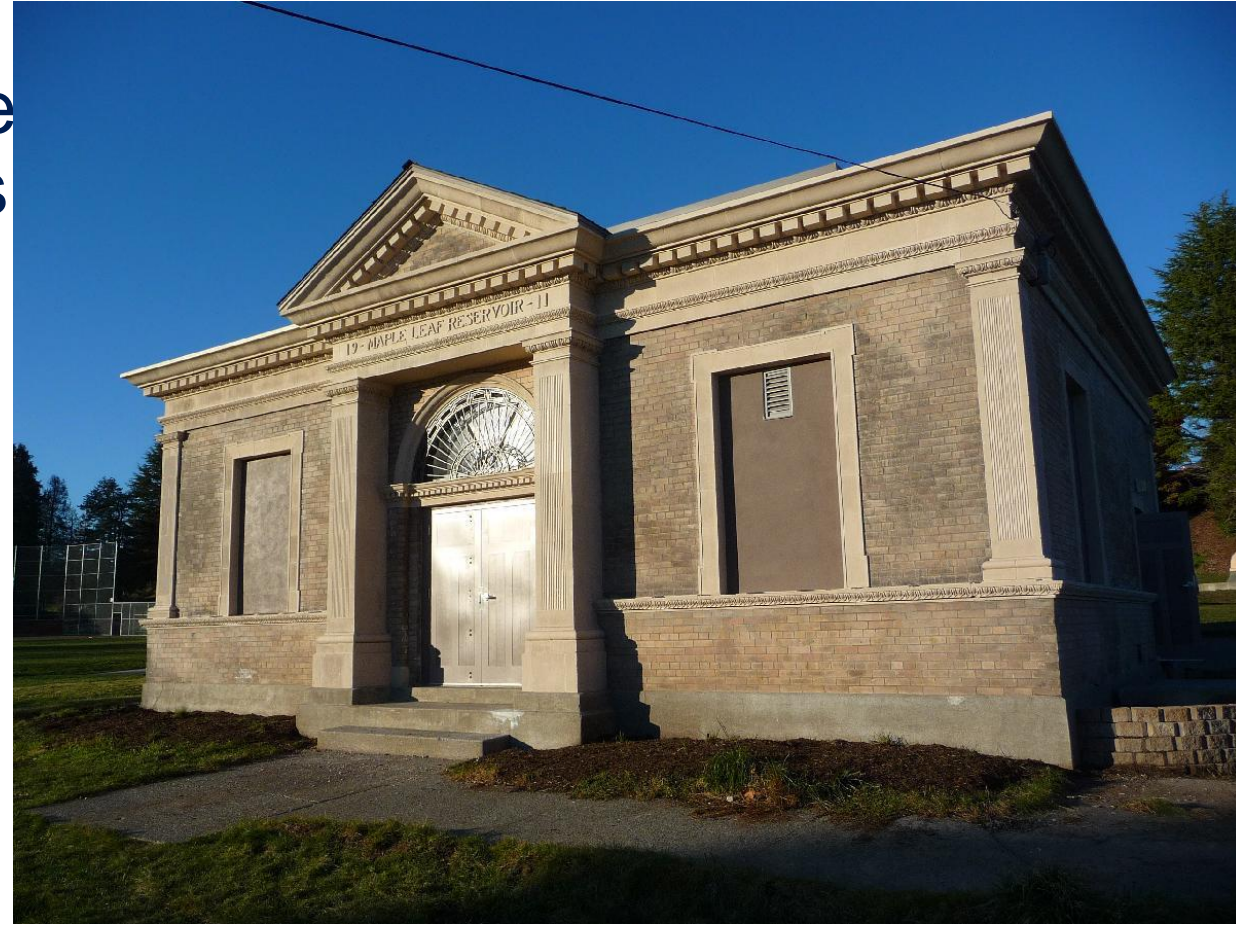
# Regional Pump Stations

Several Pump Stations Are Vulnerable  
But Most of Vulnerable Pump Stations  
Are Not Critical
